STEPS FOR SAFE DESIGN AND CONSTRUCTION OF MULTISTOREY REINFORCED CONCRETE BUILDINGS

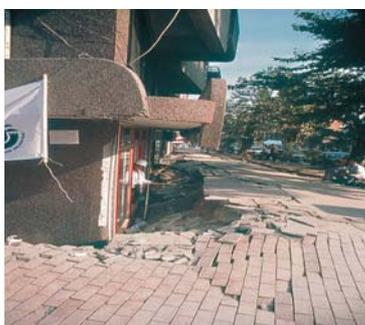
Fig. 1
The Building Sank evenly about 1 m due to soil liquefaction. The displaced soil caused a bulge in the road.

- (vi) If the soil is sandy and water table is high, it may liquefy. See IS:1893-2002 Cl 6.3.5.2 and Table 1 for minimum N (corrected values) for safety and carryout soil liquefaction analysis by standard procedures available in the literature. The adverse effects of liquefaction may be seen in Figs. 1, 2 & 3.

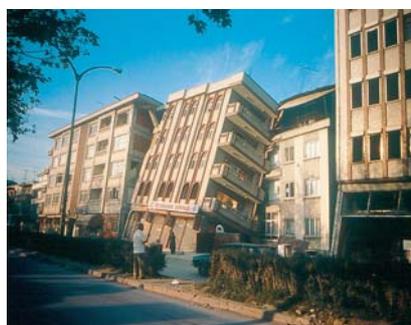
Fig. 2
This inclined building sank unevenly and leans against a neighbouring building

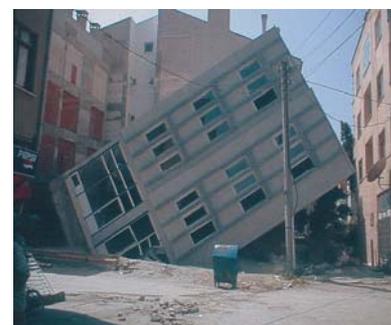
Fig. 3
The solid building tilted as a rigid body and the raft foundation rises above the ground

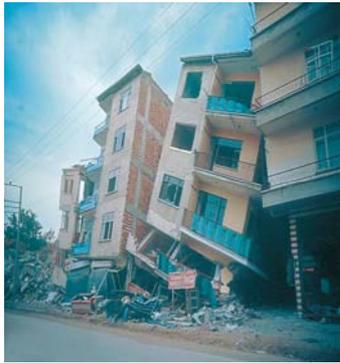
Fig. 4
Sway mechanisms with soft storey ground floors (Izmit, Turkey 1999)

Behaviour of soft first storey buildings (buildings on *stilts* or with *open plinth*) during earthquakes may be seen in Figs. 4, 5 & 6.

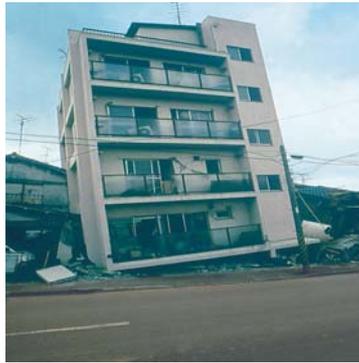
Fig. 5
Soft first storey collapsed, upper part of the building fall onto the ground, (kachchh, 2001)

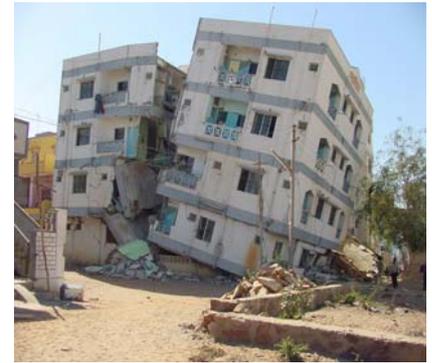
Fig. 6
Soft Storey (Open Plinth), Vertical Split between two blocks (Bhuj)

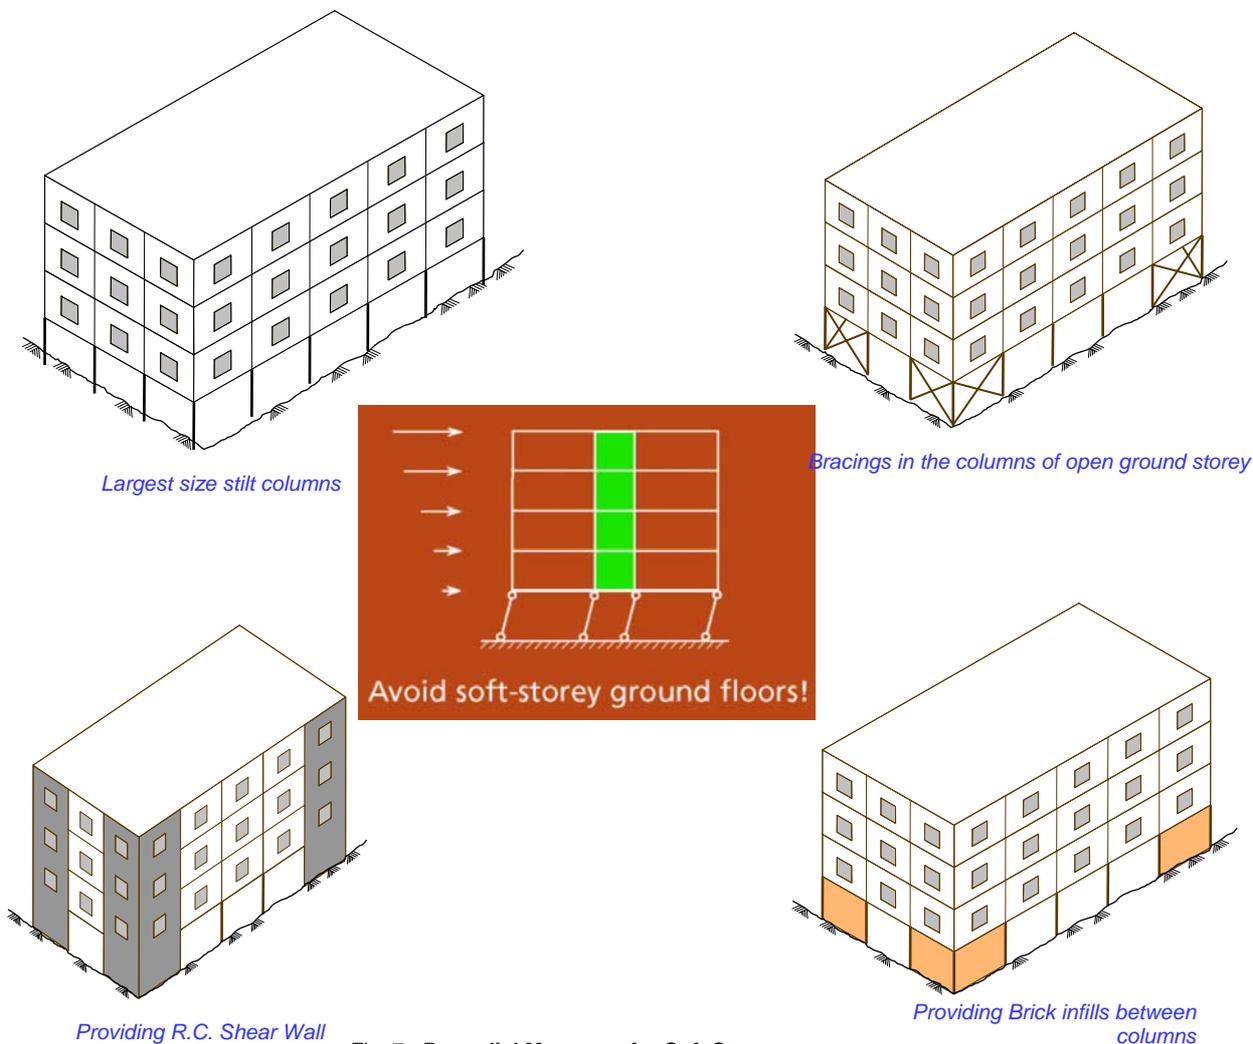
Fig. 7:- Remedial Measures for Soft Storey

Some remedial measures to counter the bad performance are shown in Fig. 7.

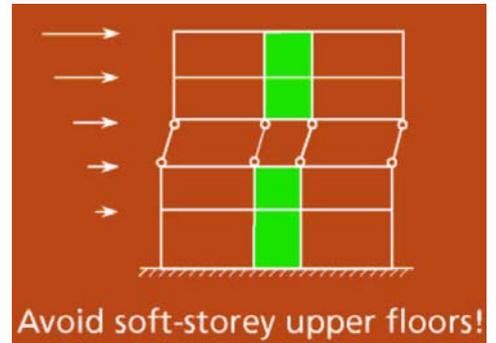
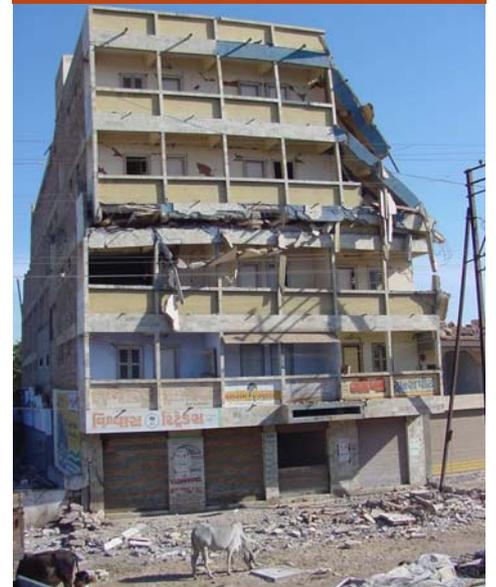
Fig.8:- Collapse of soft middle storey in a building at Bhuj.

Some times a soft storey is created some where at mid-height of the multi-storey building, for using the space as restaurant or gathering purposes, see fig.8. Such soft storey in building also collapsed in Kutch and Kobe earthquakes. For such a case also, the storey columns should be designed for the higher forces OR a few shear walls introduced to make up for the reduced stiffness of the storey.

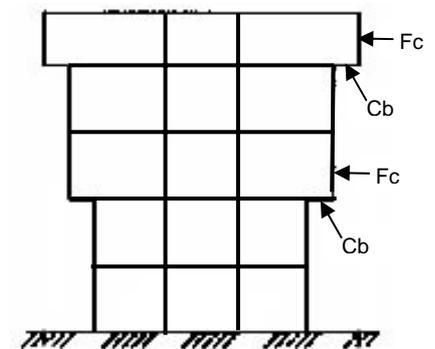
Fig.9:- Floating columns
Fc= Floating Columns
Cb= Cantilever Beams

The structural system adopted using floating columns, for reasons of higher FSI is very undesirable in earthquake zones of moderate to high intensity as in Zone III, IV & V since it will induce large vertical earthquake forces even under horizontal earthquake ground motions due to overturning effects.

The structural engineer should provide for the *load path* in the building from roof to the foundation. For example, a building with floating columns requires transfer of the floating column loads to horizontal cantilever beams through shear forces. The *load path*, therefore, is not vertical but changes from vertical to horizontal members before reaching the foundation. Sometimes similar situations arise within the frames where, for any reason, either the beam is missing or a column is missing. These are structural discontinuities and should better be avoided as far as possible. Other irregularities such as those defined in Table 4 & 5 of IS: 1893-2002 (Part 1) become the cause for large *torsional moments* and *stress concentration* in the buildings which should better be avoided by the architect and structural engineer in the initial planning of the building configuration. Otherwise, they should be carefully considered in structural analysis and properly detailed in the structural design.

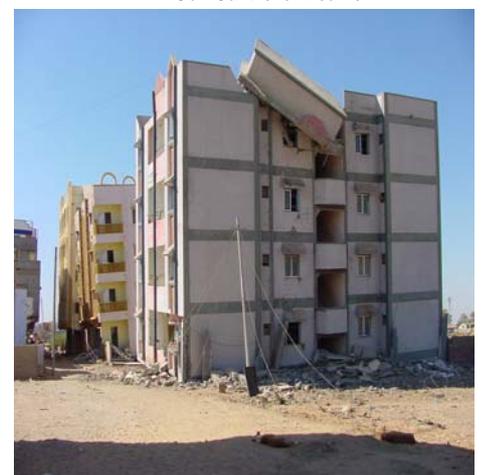
Fig.10
5 storey R.C., collapse of open plinth, water tank at top dislocated (Bhuj)

Heavy water tanks add large lateral inertia forces on the building frames due to the so called ‘whipping’ effect under seismic vibrations, but remain unaccounted for in the design. See the fall of such water tank in Fig.10

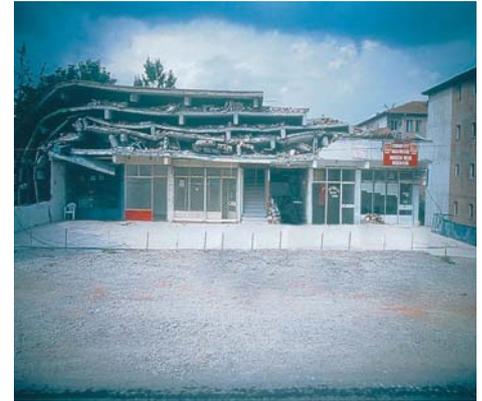
All the upper floors weak in long directions (Izmit, Turkey 1999)

In spite of that, the structural designers ignored the seismic forces in design. It may also be stated that most buildings are designed against lateral load in the *transverse direction*. Hence they collapse in the *longitudinal directions*.

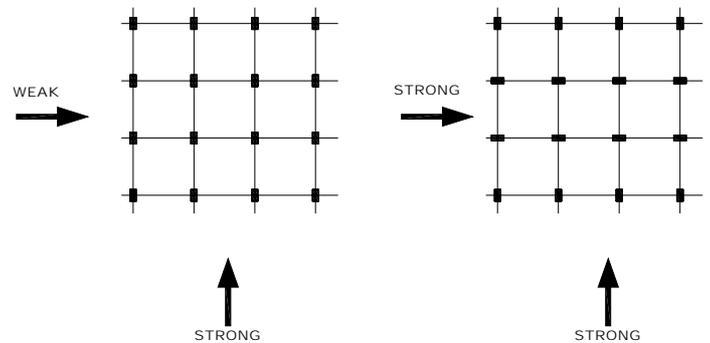
Fig.11:- Lateral Strength of Building Frame

Proper arrangement of columns is shown in Fig. 11 which would give adequate seismic resistance along both axes of the building.

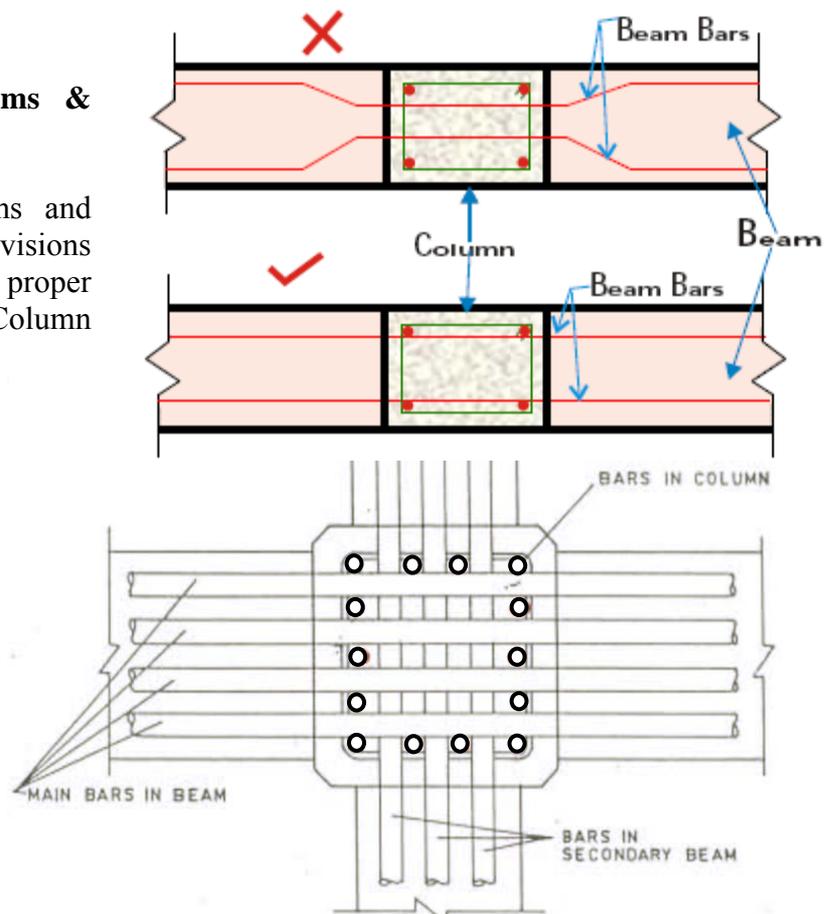
Fig.13:- Plan of Reinforcement in Beams & Columns

The relative dimensions of beams & columns become very important in tall buildings from the point of view of provision of longitudinal & transverse reinforcement in the members as well as the reinforcement passing through and anchored in the beam-column joints, permitting enough space for proper concreting and without involving any local kinking of the reinforcing bars. The practice of using small dimension columns like 200 or

230 mm and *beams of equal width* is totally unacceptable from the reinforcement detailing view point. Infact for permitting the beam bars passing through the columns, without any local bending then straightening (introducing kinks), the proper scheme would be to use wider columns than the beams. Minimum dimensions of beams and columns, also limiting aspect ratios of the two members, are specified in IS: 13920 which need to be adhered to.

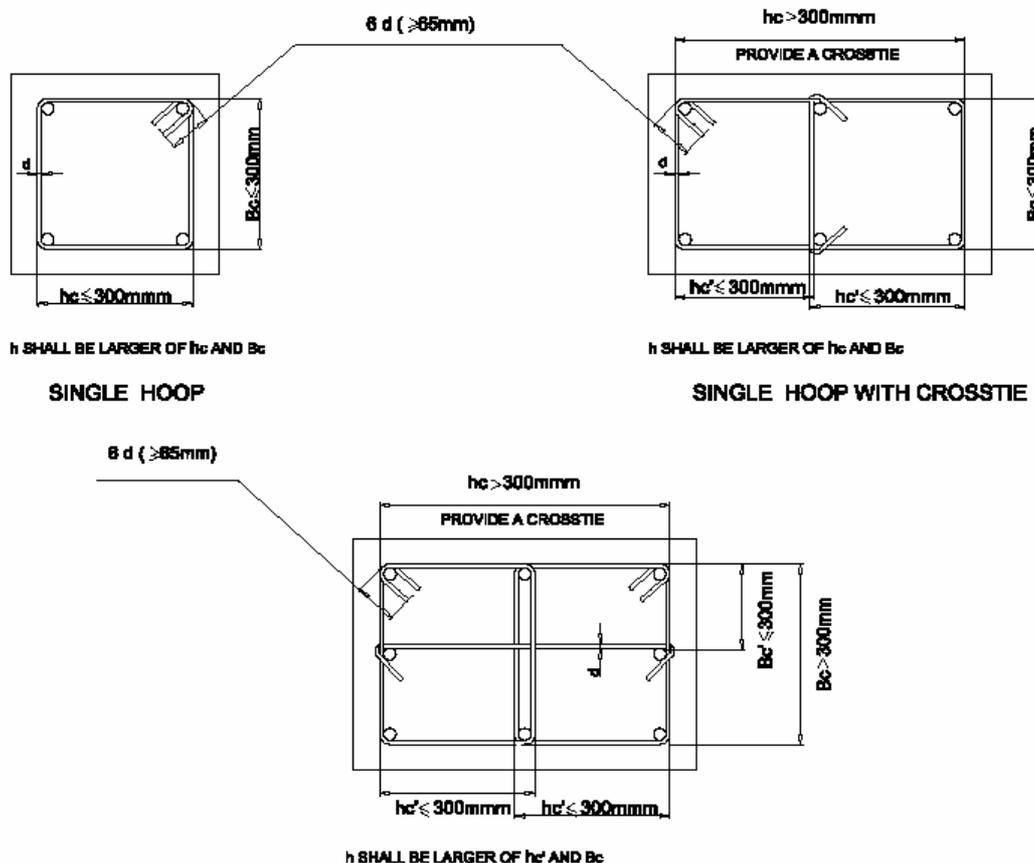
Fig.13:- Detailing of reinforcement (Overlapping Hoops & Crosstie)

In respect of proper detailing of reinforcement in beams, columns, beam-column joints as well as shear walls, all the provisions in IS:13920 have to be carefully understood and adopted in design. The *philosophy of over-design of beams in shear to force flexural hinge formation before shear failure, confining of highly compressed concrete in columns* and the use of properly shaped *shear stirrups with 135 degree hooks* are some low-cost but extremely important provisions. For overall safety of the frame, design based on the concept of *strong-column, weak-beam* system should be adopted as far as practical. It may be mentioned that the full ductility details as specified in IS: 13920 permit the use of the High Reduction Factor $R=5$ which would make the design economical. But if such ductility details are not adopted, the Reduction Factor is permitted as only 3.0, which means that the design force will become 1.67 times the case when full ductile detailing is adopted which may indeed turnout to be more expensive and at the same time brittle and relatively unsafe (see fig.13).

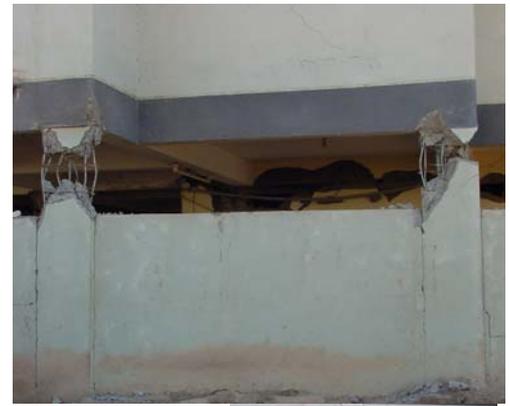
Fig.14:- Damage to buildings due to short column effect on columns

In some situations the column is surrounded by walls on both sides such as upto the window sills and then in the spandrel portion above the windows but it remains exposed in the height of the windows. Such a column behaves as a short column under lateral earthquake loading where the shear stresses become much higher than normal length columns and fail in shear. (See fig. 14)

To safe guard against this brittle shear failure in such columns the special confining stirrups should be provided throughout the height of the column at short spacing as required near the ends of the columns.

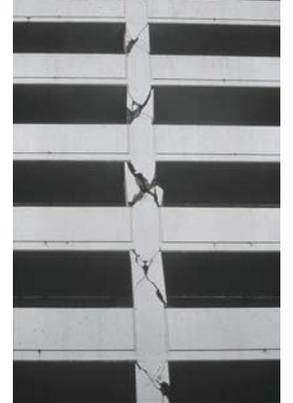
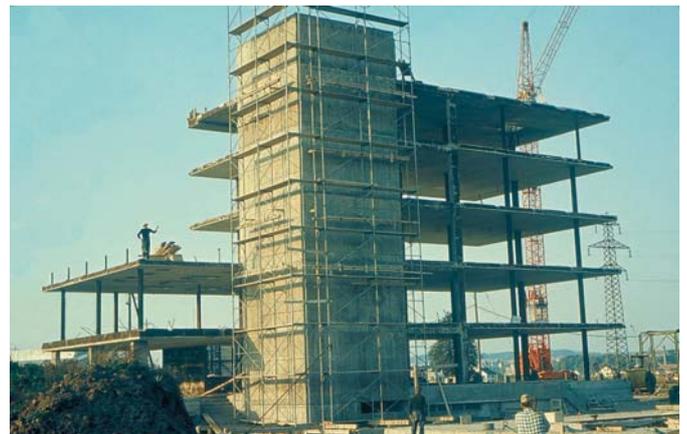
Fig.15:- Very unsymmetrical building

Torsional failures are seen to occur where the symmetry is not planned in the location of the lateral structural elements as for example providing the lift cores at one end of the building or at one corner of the building or unsymmetrically planned buildings in L shape at the street corners. Large torsional shears are caused in the building columns causing there torsional shear failures (See fig.15).

Where site requirements of from functional requirements control the building plan shape, either it should be split into two symmetrical rectangular blocks by providing separation sections of appropriate with between the blocks or the structural elements should be so adjusted that the centre of stiffness and the centre of mass should coincide along both axis of the building needless to say that any non-coincidence of the centre of mass and centre of stiffness should be taken into design calculations as per IS:1893

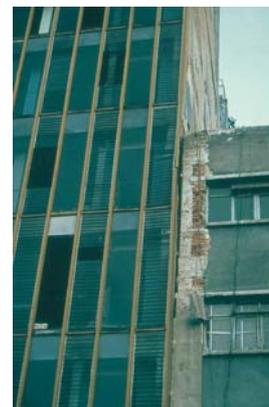
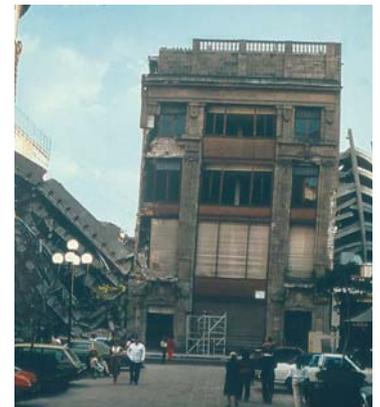
Fig.16:- Pounding damage of adjacent buildings

Severe damage even leading to collapse are seen due to severe impact between two adjacent buildings under earthquake shaking if the adjacent blocks of a building or two adjacent buildings are of different heights with floors at different levels and with inadequate separation. Such buildings can vibrate out of phase with each other due to very different natural frequencies thus hitting each other quite severely (see fig.16).

To avoid such pounding damage the amount of separation between them should be liberally provided so as to cater for the combined maximum out of phase displacements. A simple recommendation is given in IS:4326 (Cl.5.1.2) for flexible as well as stiff buildings which must be adopted as a minimum to avoid the possibility of pounding between two unsimilar buildings/blocks

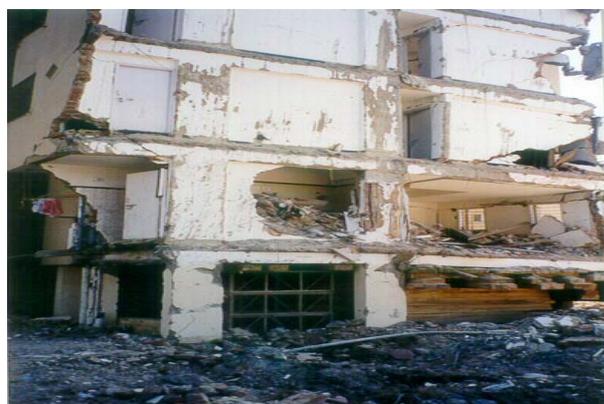
Fig. 17:- Infill wall damage

The infill walls were not properly attached either to the column or the top beams for stability against out-of-plane bending under horizontal earthquake forces. Their cracking and falling was widespread (See Fig. 17).

Stability of infill walls is important in two ways: first, they introduce their brittle failure due to the diagonal compression in the panel and or diagonal tension cracking; secondly, and more important is their lateral stability under out of plane earthquake force acting on their own mass. While conducting the retrofitting studies of three lifeline buildings in Delhi, the *114 mm thick brick infill walls* have turned out to be one of the main issues to handle while retrofitting the building so as to save the inmates and the property inside from damage due to the failure of the infill walls. It has been found that such walls will have to be contained with in pairs of vertical angles spaced at 1.2 – 1.5 m apart. Therefore, while designing a new multistoried building, the stabilisation of the infill wall panels should be properly considered either by providing confining angles near the top or by providing slits on the vertical sides and stabilising by the means of vertical angles or channels.
